**Flood Control Project Maintenance
Levee Inspections**

Maintenance Issue Types Only, Levee Inspection Report By Mile - Spring 2015

San Joaquin County Flood Control and Water Conservation District

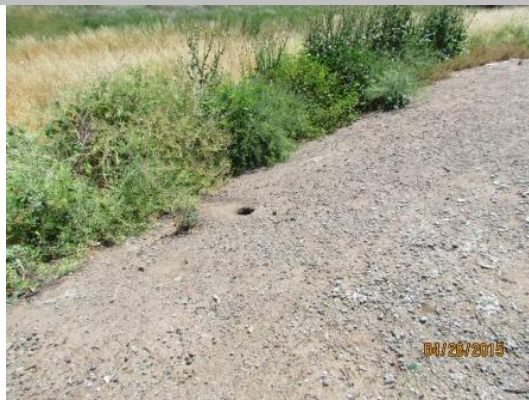
Photo 1 of 1 : SP_2015_NA0017_159_205_20150429_00143.jpg

Rodent holes were found on the waterside of the levee looking downstream.

LM Start	21.43	Rating **	M	Issue No.	205
LM End	21.43	Issue Type +	Ma	Location *	WS
Category	Earthen Levee			GPS Latitude/Longitude	
				Start	End
Item	Animal Control			37.986658 °	37.986658 °
				-121.308232 °	-121.308232 °
DWR ID	DWR_NA0017_15_s_2015_205				
Action/Comments					
No rodents visible, but rodent burrows visible; need to backfill and compact or grout burrows.

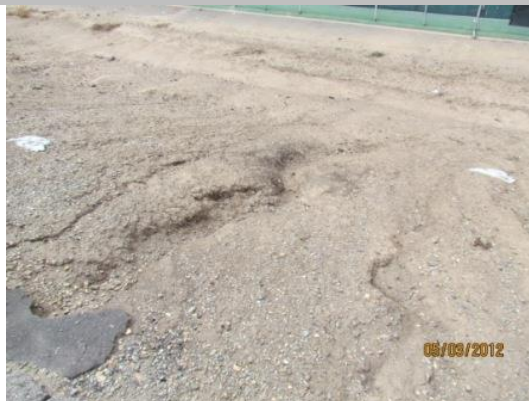
Photo 1 of 3 : SP_2015_NA0017_159_173_20150313_00098.jpg

Erosion was found due to runoff on the landside of the levee looking downstream.

LM Start	21.97	Rating **	M	Issue No.	173
LM End	21.97	Issue Type +	Ma	Location *	LS
Category	Earthen Levee			GPS Latitude/Longitude	
				Start	End
Item	Erosion / Bank Caving			37.981068 °	37.981068 °
				-121.315159 °	-121.315159 °
DWR ID	DWR_NA0017_15_s_2012_173				
Action/Comments					
Schedule repair of erosion site prior to the next inspection.

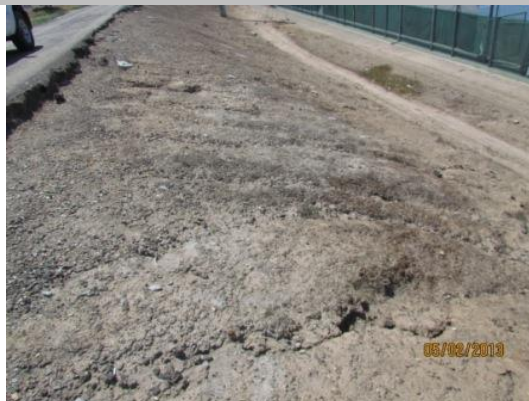
Photo 2 of 3 : SP_2015_NA0017_159_173_20150313_00099.jpg

Updated picture of the erosion caused by run off on the landside slope of the levee looking downstream during spring 2013 inspection.

LM Start	21.97	Rating **	M	Issue No.	173 (cont)
LM End	21.97	Issue Type +	Ma	Location *	LS
Category	Earthen Levee			GPS Latitude/Longitude	
				Start	End
Item	Erosion / Bank Caving			37.981068 °	37.981068 °
				-121.315159 °	-121.315159 °
DWR ID	DWR_NA0017_15_s_2012_173				
Action/Comments					
Schedule repair of erosion site prior to the next inspection.

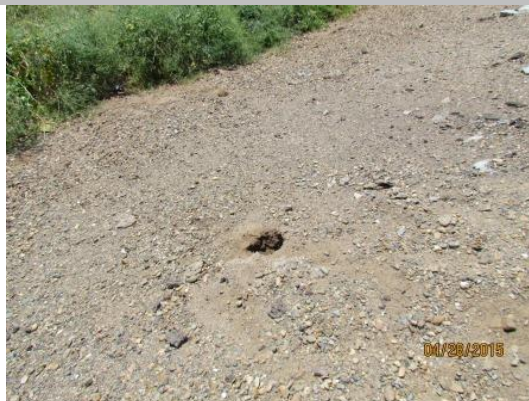
Photo 1 of 1 : SP_2015_NA0017_159_206_20150429_00146.jpg

Rodent holes were found on the waterside of the levee looking upstream.

LM Start	22.50	Rating **	M	Issue No.	206
LM End	22.50	Issue Type +	Ma	Location *	WS
Category	Earthen Levee			GPS Latitude/Longitude	
				Start	End
Item	Animal Control			37.981711 °	37.981711 °
				-121.323954 °	-121.323954 °
DWR ID	DWR_NA0017_15_s_2015_206				
Action/Comments					
No rodents visible, but rodent burrows visible; need to backfill and compact or grout burrows.

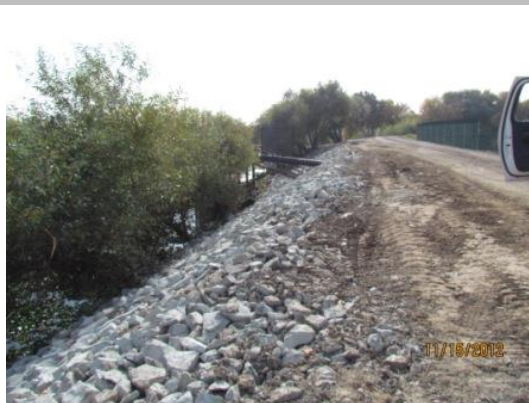
Photo 1 of 1 : SP_2015_NA0017_159_187_20150313_00106.jpg

LM Start	24.00	Rating **	A/W	Issue No.	187
LM End	24.00	Issue Type +	Ma	Location *	WS
Category	Earthen Levee			GPS Latitude/Longitude	
				Start	End
Item	Riprap Revetments			37.974858 °	37.974858 °
				-121.347718 °	-121.347718 °
DWR ID	DWR_NA0017_15_f_2012_187				
Action/Comments

Revetment was placed by the LMA on the waterside slope of the levee looking downstream.

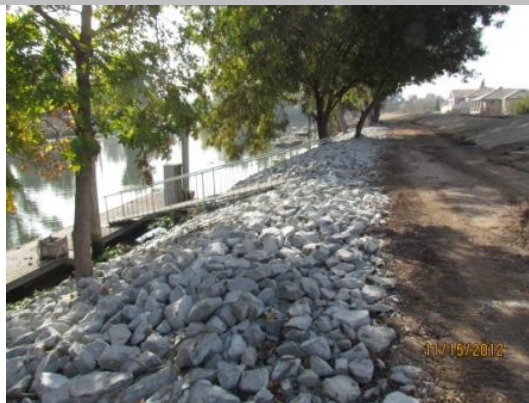
Photo 1 of 1 : SP_2015_NA0017_159_188_20150313_00107.jpg

LM Start	24.65	Rating **	A/W	Issue No.	188
LM End	24.65	Issue Type +	Ma	Location *	WS
Category	Earthen Levee			GPS Latitude/Longitude	
				Start	End
Item	Riprap Revetments			37.969095 °	37.969095 °
				-121.356301 °	-121.356301 °
DWR ID	DWR_NA0017_15_f_2012_188				
Action/Comments

Revetments were placed by the LMA on the waterside slope of the levee looking downstream.

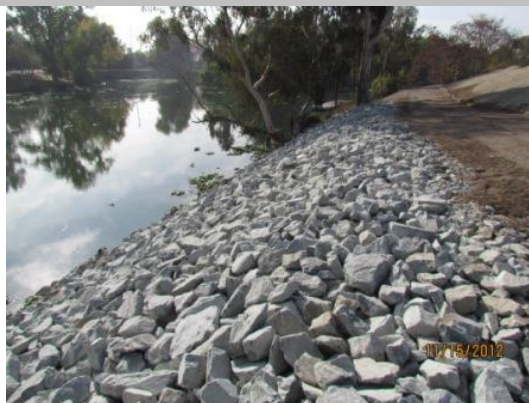
Photo 1 of 1 : SP_2015_NA0017_159_189_20150313_00108.jpg

LM Start	24.81	Rating **	A/W	Issue No.	189
LM End	24.81	Issue Type +	Ma	Location *	WS
Category	Earthen Levee			GPS Latitude/Longitude	
				Start	End
Item	Riprap Revetments			37.967943 °	37.967943 °
				-121.358711 °	-121.358711 °
DWR ID	DWR_NA0017_15_f_2012_189				
Action/Comments

Revetments were placed by the LMA on the waterside slope of the levee looking downstream.

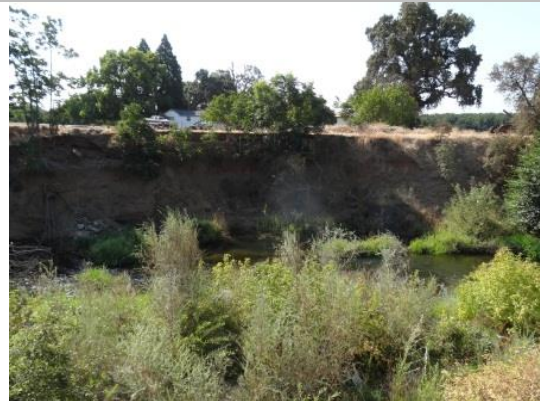
Photo 1 of 1 : SP_2015_NA0017_160_272_20150313_00159.jpg

LM Start	0.29	Rating **	U	Issue No.	272
LM End	0.29	Issue Type +	Ma	Location *	WS
Category	Supplemental			GPS Latitude/Longitude	
				Start	End
Item	DWR Erosion Survey			38.048159 °	38.048159 °
				-121.016427 °	-121.016427 °
DWR ID	DWR_NA0017_16_s_2015_272				
Action/Comments					
Inspector Comments: 8/20/2014: The erosion at the site has worsened. The erosion increased both in both length and in height. 09/12/2013: Site has been visited and signs of new erosion are visible. 08/22/2012: The erosion was surveyed and documented for monitoring purpose. There is no levee structure on the site, only high ground protecting the land behind. The levee crest width and levee height were not measured or estimated in the field. [2014 Site ID:NA0017U16RM23.35]

Close view of the erosion.

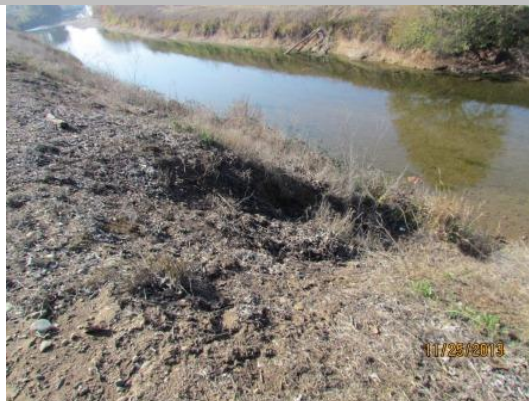
Photo 1 of 1 : SP_2015_NA0017_160_155_20150313_00091.jpg

LM Start	1.91	Rating **	M	Issue No.	155
LM End	1.91	Issue Type +	Ma	Location *	WS
Category	Earthen Levee			GPS Latitude/Longitude	
				Start	End
Item	Erosion / Bank Caving			38.036248 °	38.036248 °
				-121.040408 °	-121.040408 °
DWR ID	DWR_NA0017_16_f_2013_155				
Action/Comments					
Schedule repair of erosion site prior to the next inspection.

Erosion was found on the waterside of the levee looking downstream.

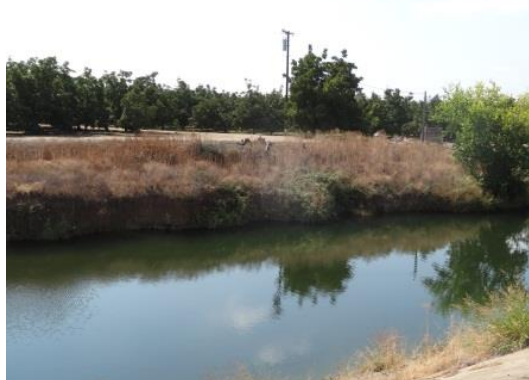
Photo 1 of 1 : SP_2015_NA0017_160_217_20150313_00137.jpg

LM Start	1.93	Rating **	M	Issue No.	217
LM End	1.95	Issue Type +	Ma	Location *	WS
Category	Supplemental			GPS Latitude/Longitude	
				Start	End
Item	DWR Erosion Survey			38.037150 °	38.037150 °
				-121.040580 °	-121.040580 °
DWR ID	DWR_NA0017_16_s_2015_217				
Action/Comments					
Inspector Comments: 8/20/2014: No significant change observed. 9/12/2013: No significant change observed. 08/22/2012: Berm width is estimated as 5 ft. There is no levee structure on site. The levee crest width and levee height were not measured or estimated in the field. [2014 Site ID:NA0017U16RM21.05]

Front view of the erosion

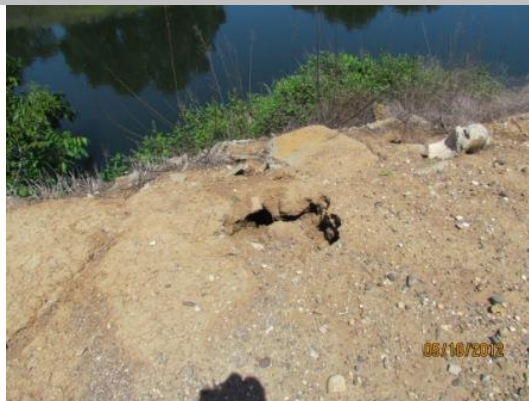
Photo 2 of 2 : SP_2015_NA0017_160_213_20150313_00134.jpg

LM Start	2.35	Rating **	M	Issue No.	213 (cont)	
LM End	2.35	Issue Type +	Ma	Location *	WS	
Category	Earthen Levee			GPS Latitude/Longitude		
				Start		End
Item	Slope Stability			38.031763 °	38.031763 °	
				-121.045808 °	-121.045808 °	
DWR ID	DWR_NA0017_16_f_2012_213					
Action/Comments						
Repair slope instability.

Slope instability was found on the waterside of the levee looking upstream.

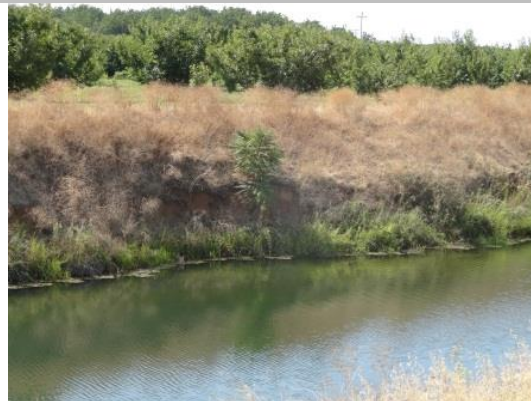
Photo 1 of 1 : SP_2015_NA0017_160_212_20150313_00132.jpg

LM Start	2.88	Rating **	U	Issue No.	212
LM End	2.88	Issue Type +	Ma	Location *	WS
Category	Supplemental			GPS Latitude/Longitude	
				Start	End
Item	DWR Erosion Survey			38.026670 °	38.026670 °
				-121.053031 °	-121.053031 °
DWR ID	DWR_NA0017_16_s_2015_212				
Action/Comments					
Inspector Comments: 8/20/2014: No significant change observed. 9/12/2013: No significant change observed. 08/22/2012: Site Comprised of series of pocket and scarp erosions. Some of erosions are covered by grass or shrubs. There is no levee structure on site. The levee crest width and levee height were not measured or estimated in the field. [2014 Site ID:NA0017U16RM20]

Front view of the erosion.

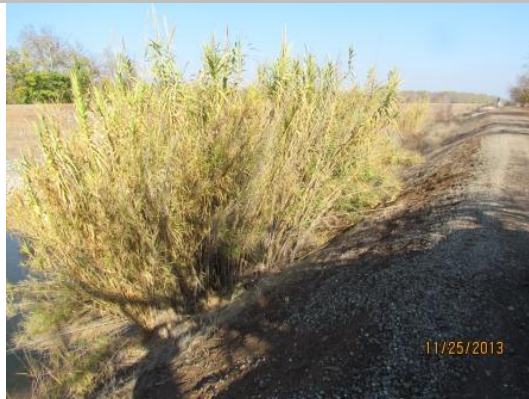
Photo 1 of 1 : SP_2015_NA0017_160_152_20150313_00089.jpg

LM Start	3.48	Rating **	M	Issue No.	152
LM End	3.48	Issue Type +	Ma	Location *	WS
Category	Earthen Levee			GPS Latitude/Longitude	
				Start	End
Item	Vegetation			38.020965 °	38.020965 °
				-121.061215 °	-121.061215 °
DWR ID	DWR_NA0017_16_f_2013_152				
Action/Comments					
Remove the wild growth other than native grasses from the levee slopes.

Arundo was found on the waterside toe of the levee looking upstream.

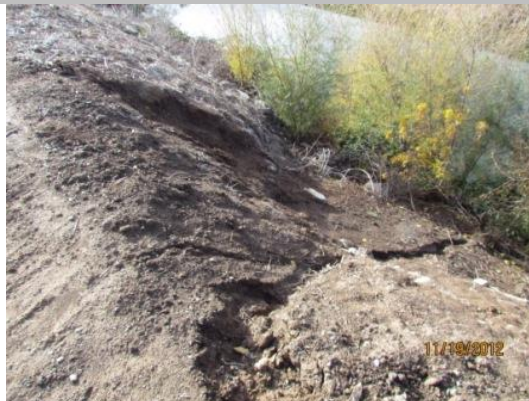
Photo 1 of 2 : SP_2015_NA0017_160_230_20150313_00145.jpg

LM Start	3.53	Rating **	M	Issue No.	230
LM End	3.53	Issue Type +	Ma	Location *	WS
Category	Earthen Levee			GPS Latitude/Longitude	
				Start	End
Item	Erosion / Bank Caving			38.020433 °	38.020433 °
				-121.061867 °	-121.061867 °
DWR ID	DWR_NA0017_16_f_2012_230				
Action/Comments					
Schedule repair of erosion site prior to the next inspection.

Slope instability was found on the waterside slope of the levee looking downstream.

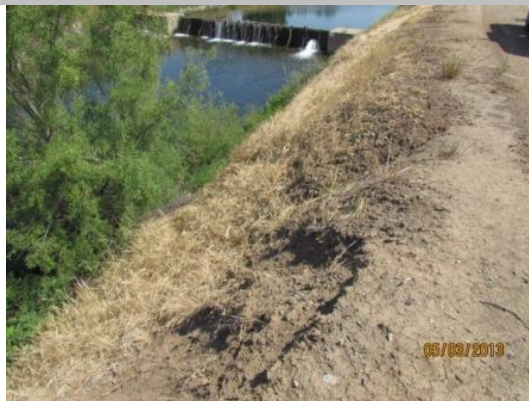
Photo 2 of 2 : SP_2015_NA0017_160_230_20150313_00144.jpg

LM Start	3.53	Rating **	M	Issue No.	230 (cont)
LM End	3.53	Issue Type +	Ma	Location *	WS

Erosion was found on the waterside slope of the levee looking upstream.

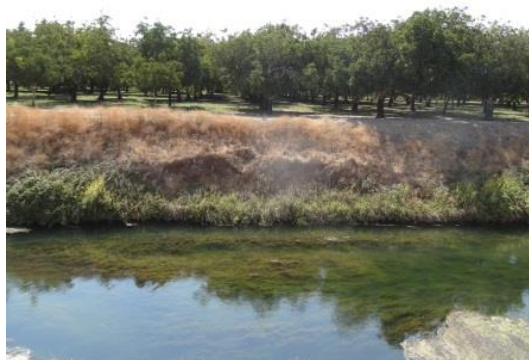
Photo 1 of 1 : SP_2015_NA0017_160_210_20150313_00131.jpg

LM Start	3.61	Rating **	M	Issue No.	210
LM End	3.61	Issue Type +	Ma	Location *	WS
Category	Supplemental			GPS Latitude/Longitude	
				Start	End
Item	DWR Erosion Survey			38.019642 °	38.019642 °
				-121.062917 °	-121.062917 °
DWR ID	DWR_NA0017_16_s_2015_210				
Action/Comments					
Inspector Comments: 8/20/2014: A pocket erosion was found near the water's edge. [2014 Site ID:NA0017U16RM19.29]

View of the site from the right river bank.

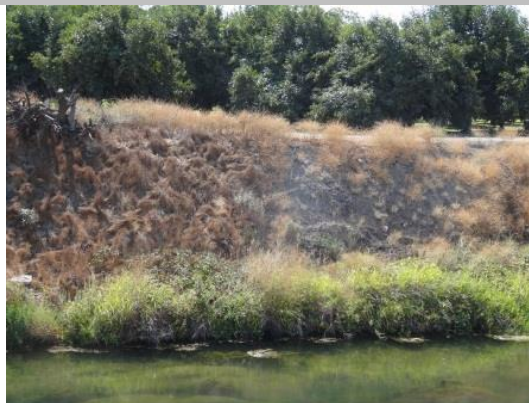
Photo 1 of 1 : SP_2015_NA0017_160_209_20150313_00130.jpg

LM Start	3.66	Rating **	M	Issue No.	209
LM End	3.66	Issue Type +	Ma	Location *	WS
Category	Supplemental			GPS Latitude/Longitude	
				Start	End
Item	DWR Erosion Survey			38.019290 °	38.019290 °
				-121.063810 °	-121.063810 °
DWR ID	DWR_NA0017_16_s_2015_209				
Action/Comments					
Inspector Comments: 8/20/2014: No significant change observed. 9/12/2013: This site has been repaired prior to this survey, but new erosion has developed immediately downstream of the site. 08/22/2012: Tow large-size pocket erosions. Site is covered with dense vegetation. There is no levee structure on site. The levee crest width and levee height were not measured or estimated in the field. [2014 Site ID:NA0017U16RM19.28]

Front view of the repaired erosion.

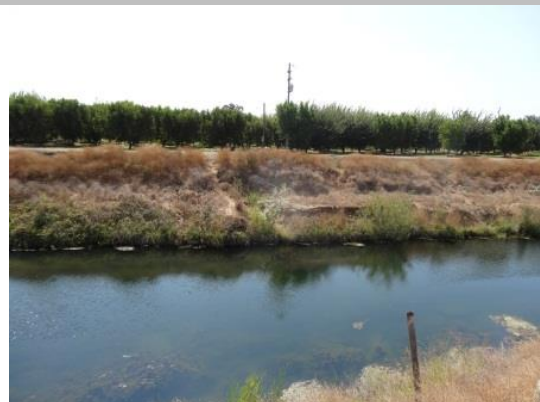
Photo 1 of 1 : SP_2015_NA0017_160_207_20150313_00129.jpg

LM Start	3.89	Rating **	M	Issue No.	207
LM End	3.91	Issue Type +	Ma	Location *	WS
Category	Supplemental			GPS Latitude/Longitude	
				Start	End
Item	DWR Erosion Survey			38.018100 °	38.018100 °
				-121.065170 °	-121.065170 °
DWR ID	DWR_NA0017_16_s_2015_207				
Action/Comments					
Inspector Comments: 8/20/2014: No significant change observed. 9/12/2013: No significant change observed. 08/22/2012: River-induced erosion occurred on the berm, while the runoff-induced erosion occurred on the levee slope. Site is covered with vegetation. There is no levee structure on site. The levee crest width and levee height were not measured or estimated in the field. [2014 Site ID:NA0017U16RM19.18]

View of the site from right river bank.

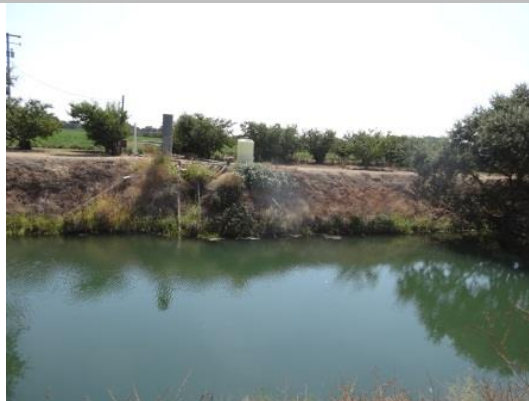
Photo 1 of 1 : SP_2015_NA0017_160_205_20150313_00127.jpg

LM Start	4.17	Rating **	U	Issue No.	205
LM End	4.17	Issue Type +	Ma	Location *	WS
Category	Supplemental			GPS Latitude/Longitude	
				Start	End
Item	DWR Erosion Survey			38.012792 °	38.012792 °
				-121.068073 °	-121.068073 °
DWR ID	DWR_NA0017_16_s_2015_205				
Action/Comments					
Inspector Comments: 8/20/2014: No significant change observed. 9/12/2013: No significant change observed. 08/22/2012: An irrigation pipe is present at the site, but probably did not cause the erosion. There is no levee structure on site. The levee crest width and levee height were not measured or estimated in the field. [2014 Site ID:NA0017U16RM18.69]

View of the erosion site.

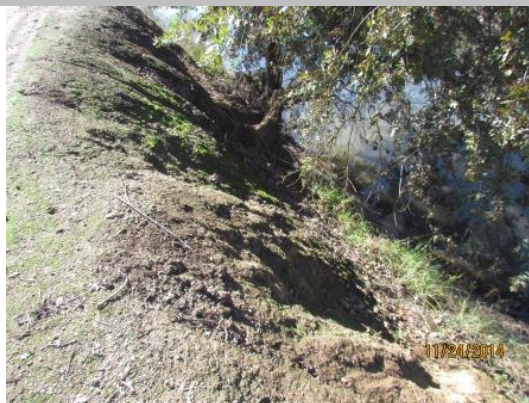
Photo 1 of 2 : SP_2015_NA0017_160_228_20150313_00142.jpg

LM Start	4.20	Rating **	M	Issue No.	228
LM End	4.20	Issue Type +	Ma	Location *	WS
Category	Earthen Levee			GPS Latitude/Longitude	
				Start	End
Item	Slope Stability			38.012288 °	38.012288 °
				-121.068239 °	-121.068239 °
DWR ID	DWR_NA0017_16_f_2012_228				
Action/Comments					
Repair slope instability.

Updated picture of the slope instability on the waterside of the levee looking downstream.

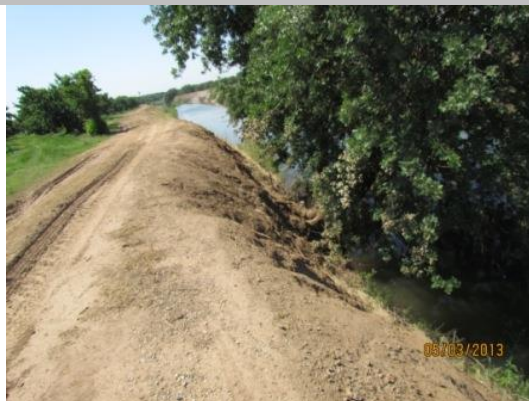
Photo 2 of 2 : SP_2015_NA0017_160_228_20150313_00143.jpg

LM Start	4.20	Rating **	M	Issue No.	228 (cont)
LM End	4.20	Issue Type +	Ma	Location *	WS

Slope instability was found on the waterside shoulder of the levee looking downstream.

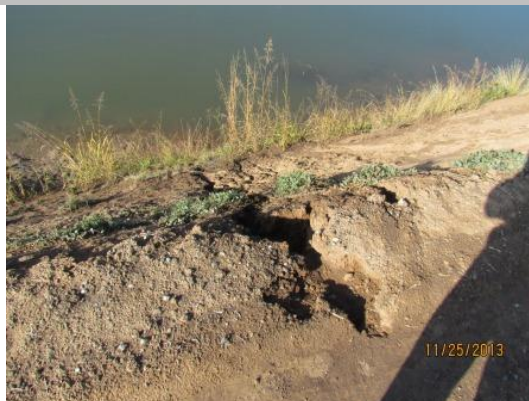
Photo 1 of 2 : SP_2015_NA0017_160_73_20150313_00040.jpg

LM Start	4.29	Rating **	M	Issue No.	73
LM End	4.29	Issue Type +	Ma	Location *	WS
Category	Earthen Levee			GPS Latitude/Longitude	
				Start	End
Item	Erosion / Bank Caving			38.011053 °	38.011053 °
				-121.068651 °	-121.068651 °
DWR ID	DWR_NA0017_16_s _ 2013_73				
Action/Comments					
Schedule repair of erosion site prior to the next inspection.

Updated picture of the erosion on the waterside of the levee looking upstream.

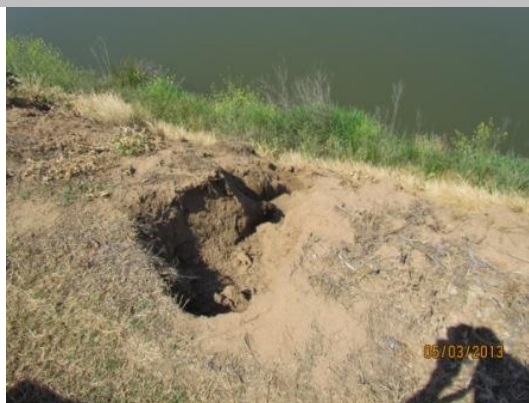
Photo 2 of 2 : SP_2015_NA0017_160_73_20150313_00041.jpg

LM Start	4.29	Rating **	M	Issue No.	73 (cont)
LM End	4.29	Issue Type +	Ma	Location *	WS

Erosion was found on the waterside shoulder of the levee looking downstream.

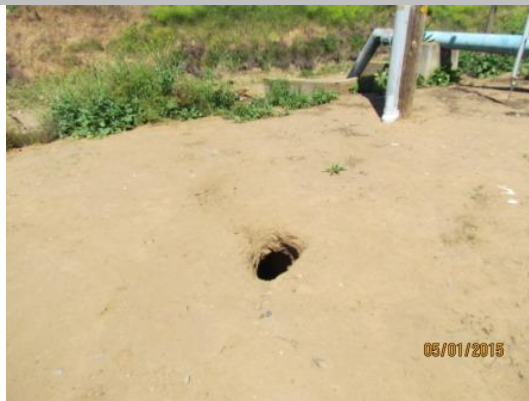
Photo 1 of 1 : SP_2015_NA0017_160_243_20150506_00164.jpg

LM Start	4.45	Rating **	M	Issue No.	243
LM End	4.45	Issue Type +	Ma	Location *	WS
Category	Earthen Levee			GPS Latitude/Longitude	
				Start	End
Item	Animal Control			38.008863 °	38.008863 °
				-121.069267 °	-121.069267 °
DWR ID	DWR_NA0017_16_s_2015_243				
Action/Comments					
No rodents visible, but rodent burrows visible; need to backfill and compact or grout burrows.

View of a rodent hole on the crown of the levee looking upstream.

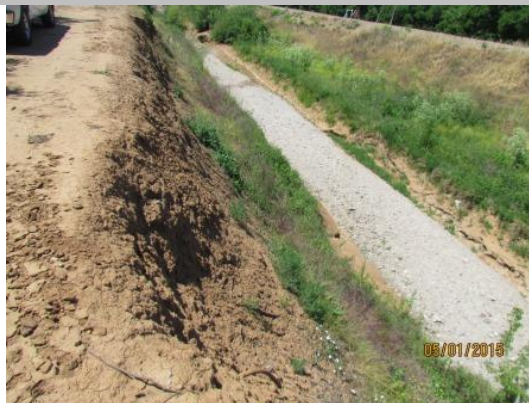
Photo 1 of 1 : SP_2015_NA0017_160_245_20150506_00165.jpg

LM Start	4.85	Rating **	M	Issue No.	245
LM End	4.85	Issue Type +	Ma	Location *	WS
Category	Earthen Levee			GPS Latitude/Longitude	
				Start	End
Item	Erosion / Bank Caving			38.003673 °	38.003673 °
				-121.072496 °	-121.072496 °
DWR ID	DWR_NA0017_16_s_2015_245				
Action/Comments					
Note and monitor erosion site.

View of erosion on the waterside slope of the levee looking downstream.

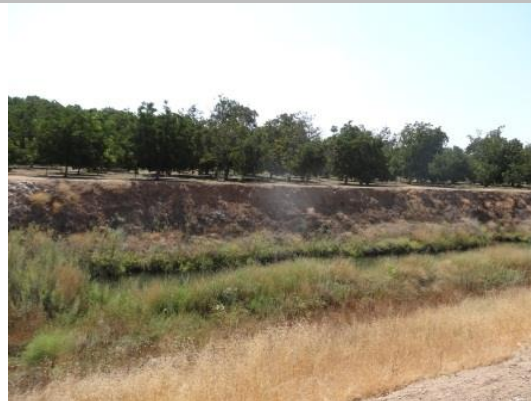
Photo 1 of 1 : SP_2015_NA0017_160_201_20150313_00124.jpg

LM Start	5.03	Rating **	U	Issue No.	201
LM End	5.03	Issue Type +	Ma	Location *	WS
Category	Supplemental			GPS Latitude/Longitude	
				Start	End
Item	DWR Erosion Survey			38.003730 °	38.003730 °
				-121.073080 °	-121.073080 °
DWR ID	DWR_NA0017_16_s _ 2015_201				
Action/Comments					
Inspector Comments: 8/20/2014: No significant change observed. 9/12/2013: Site has been surveyed and the pocket erosion has developed toward levee crest. 08/22/2012: A pocket erosion at the levee toe and on lower slope. The levee surface at the upper slope also shows signs of erosion due to poor maintenance. There is no levee structure on site. The levee crest width and levee height were not measured or estimated in the field. [2014 Site ID:NA0017U16RM17.99]

View from right river bank.

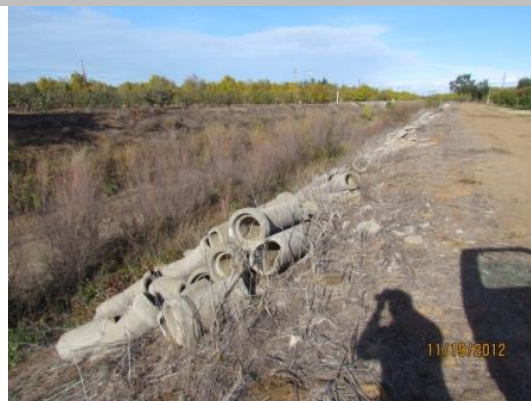
Photo 1 of 2 : SP_2015_NA0017_160_196_20150313_00120.jpg

LM Start	5.05	Rating **	M	Issue No.	196
LM End	5.15	Issue Type +	Ma	Location *	WS
Category	Earthen Levee			GPS Latitude/Longitude	
				Start	End
Item	Encroachments			38.001284 °	38.000116 °
				-121.074596 °	-121.075633 °
DWR ID	DWR_NA0017_16_s _ 2012_196				
Action/Comments					
Debris

Concrete debris was found on the waterside slope of the levee looking upstream.

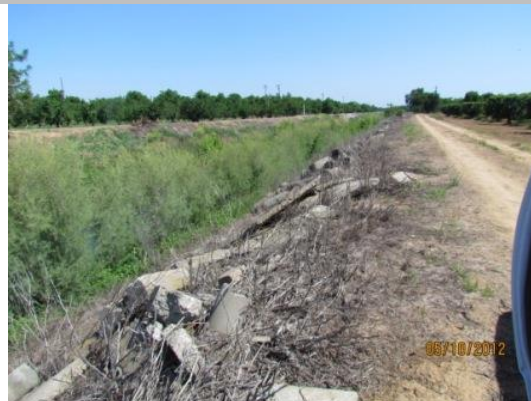
Photo 2 of 2 : SP_2015_NA0017_160_196_20150313_00121.jpg

LM Start	5.05	Rating **	M	Issue No.	196 (cont)
LM End	5.15	Issue Type +	Ma	Location *	WS

Debris was found on the waterside of the levee looking upstream.

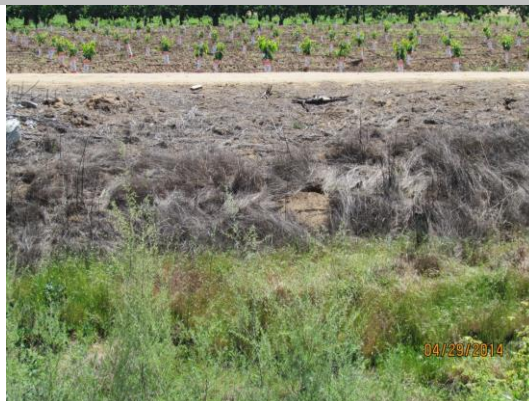
Photo 1 of 1 : SP_2015_NA0017_160_42_20150313_00016.jpg

LM Start	5.16	Rating **	M	Issue No.	42
LM End	5.16	Issue Type +	Ma	Location *	WS
Category	Earthen Levee			GPS Latitude/Longitude	
				Start	End
Item	Animal Control			38.000057 °	38.000057 °
				-121.075773 °	-121.075773 °
DWR ID	DWR_NA0017_16_s_2014_42				
Action/Comments					
No rodents visible, but rodent burrows visible; need to backfill and compact or grout burrows.

View of the animal hole on the waterside slope of the levee. The picture was taken from the opposite side of the levee.

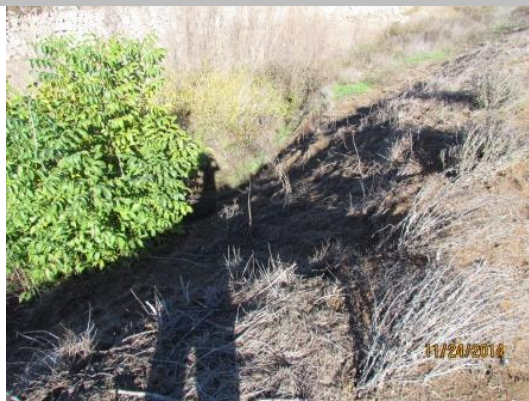
Photo 1 of 1 : SP_2015_NA0017_160_265_20150313_00154.jpg

LM Start	5.20	Rating **	M	Issue No.	265
LM End	5.20	Issue Type +	Ma	Location *	WS
Category	Earthen Levee			GPS Latitude/Longitude	
				Start	End
Item	Slope Stability			37.999537 °	37.999537 °
				-121.076133 °	-121.076133 °
DWR ID	DWR_NA0017_16_f_2014_265				
Action/Comments					
Repair slope instability.

A slope instability was found on the waterside slope of the levee looking upstream.

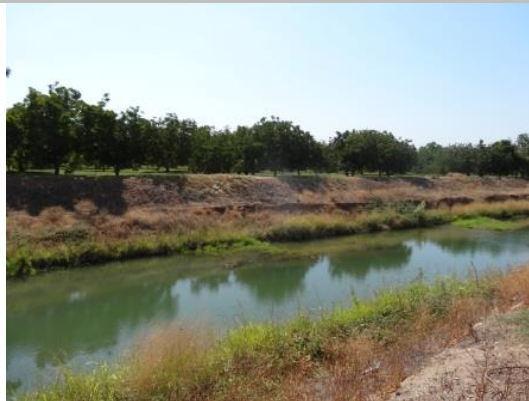
Photo 1 of 1 : SP_2015_NA0017_160_177_20150313_00113.jpg

LM Start	5.35	Rating **	M	Issue No.	177
LM End	5.35	Issue Type +	Ma	Location *	WS
Category	Supplemental			GPS Latitude/Longitude	
				Start	End
Item	DWR Erosion Survey			37.997720 °	37.997720 °
				-121.077807 °	-121.077807 °
DWR ID	DWR_NA0017_16_s_2015_177				
Action/Comments					
Inspector Comments: 8/20/2014: No significant change observed. 9/12/2013: No significant change observed. 08/22/2012: The site is located at the opposite river bank of E. Tobacco Road. There is no levee structure on site. The levee crest width and levee height were not measured or estimated in the field. [2014 Site ID:NA0017U16RM17.81]

Upstream view of the site.

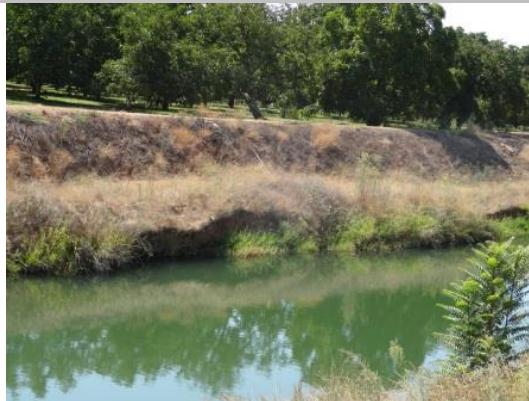
Photo 1 of 1 : SP_2015_NA0017_160_173_20150313_00108.jpg

LM Start	5.57	Rating **	U	Issue No.	173
LM End	5.57	Issue Type +	Ma	Location *	WS
Category	Supplemental			GPS Latitude/Longitude	
				Start	End
Item	DWR Erosion Survey			37.995216 °	37.995216 °
				-121.080159 °	-121.080159 °
DWR ID	DWR_NA0017_16_s_2015_173				
Action/Comments					
Inspector Comments: 8/20/2014: No significant change observed. 9/12/2013: The erosion seems to be caused by high river flow. Dense vegetation is present at the site. Signs of animal activities are visible. There is no levee structure on site. The levee crest width and levee height were not measured or estimated in the field. [2014 Site ID:NA0017U16RM17.27]

View from the right river bank.

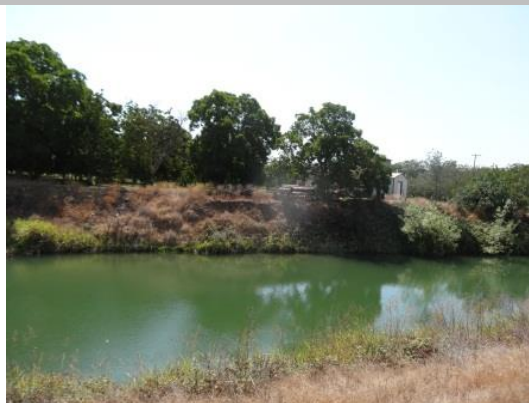
Photo 1 of 1 : SP_2015_NA0017_160_171_20150313_00106.jpg

LM Start	5.71	Rating **	M	Issue No.	171
LM End	5.71	Issue Type +	Ma	Location *	WS
Category	Supplemental			GPS Latitude/Longitude	
				Start	End
Item	DWR Erosion Survey			37.993525 °	37.993525 °
				-121.081679 °	-121.081679 °
DWR ID	DWR_NA0017_16_s _ 2015_171				
Action/Comments					
Inspector Comments: 8/20/2014: The erosion is near a tree and probably has been made worse by the unstable bank slope. [2014 Site ID:NA0017U16RM17.11]

View of the site from the right river bank.

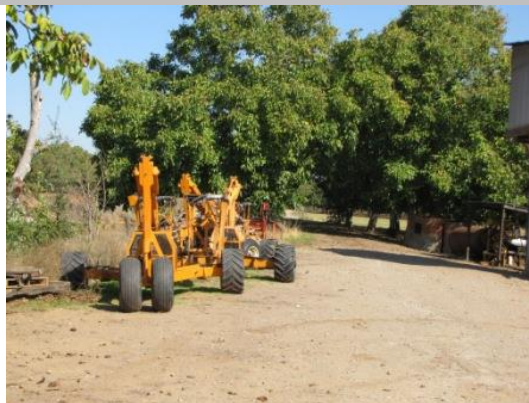
Photo 1 of 1 : SP_2015_NA0017_160_172_20150313_00107.jpg

LM Start	5.75	Rating **	M	Issue No.	172
LM End	5.75	Issue Type +	Ma	Location *	WS
Category	Earthen Levee			GPS Latitude/Longitude	
				Start	End
Item	Encroachments			37.993108 °	37.993108 °
				-121.082033 °	-121.082033 °
DWR ID	DWR_NA0017_16_s _ 2012_172				
Action/Comments					
Equipment

View of equipment located on the waterward side looking upstream.

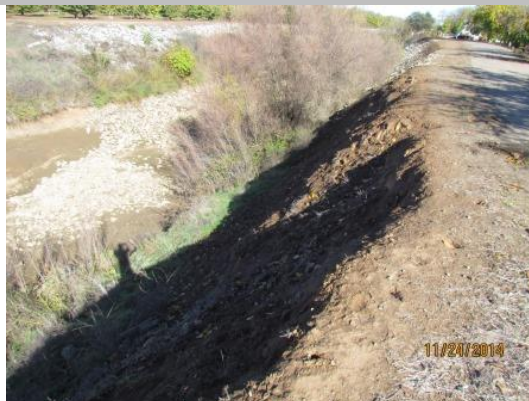
Photo 1 of 1 : SP_2015_NA0017_160_264_20150313_00153.jpg

LM Start	5.87	Rating **	M	Issue No.	264
LM End	5.87	Issue Type +	Ma	Location *	WS
Category	Earthen Levee			GPS Latitude/Longitude	
				Start	End
Item	Slope Stability			37.991628 °	37.991628 °
				-121.083312 °	-121.083312 °
DWR ID	DWR_NA0017_16_f_2014_264				
Action/Comments					
Repair slope instability.

A slope instability was found on the waterside of the levee looking upstream.

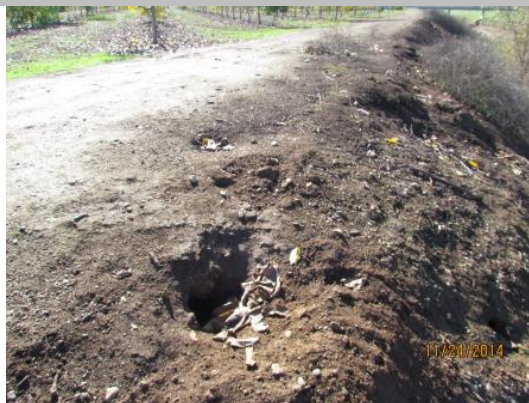
Photo 1 of 2 : SP_2015_NA0017_160_170_20150313_00104.jpg

LM Start	6.15	Rating **	M	Issue No.	170
LM End	6.15	Issue Type +	Ma	Location *	WS
Category	Earthen Levee			GPS Latitude/Longitude	
				Start	End
Item	Animal Control			37.988385 °	37.988385 °
				-121.086292 °	-121.086292 °
DWR ID	DWR_NA0017_16_s_2012_170				
Action/Comments					
No rodents visible, but rodent burrows visible; need to backfill and compact or grout burrows.

Updated picture of the rodent holes on the waterside shoulder of the levee looking downstream.

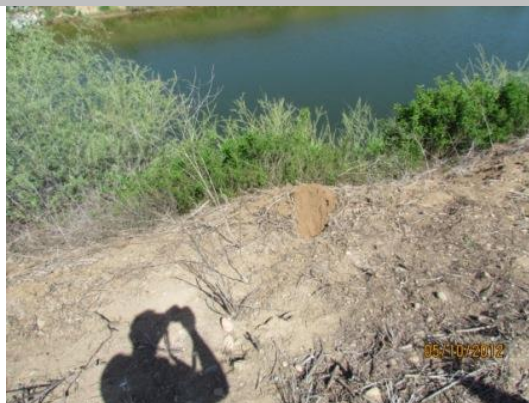
Photo 2 of 2 : SP_2015_NA0017_160_170_20150313_00105.jpg

An animal hole was found on the waterside of the levee looking upstream.

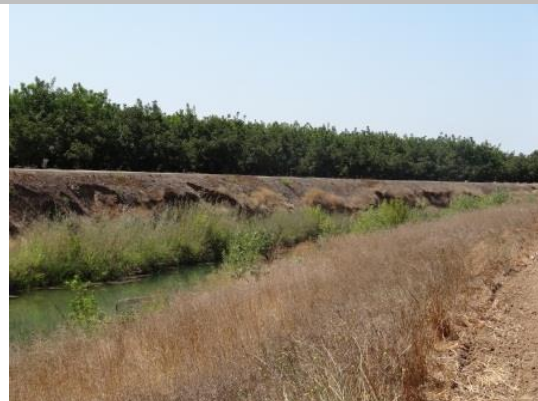
Photo 1 of 1 : SP_2015_NA0017_160_169_20150313_00103.jpg

LM Start	6.58	Rating **	U	Issue No.	169
LM End	6.58	Issue Type +	Ma	Location *	WS
Category	Supplemental			GPS Latitude/Longitude	
				Start	End
Item	DWR Erosion Survey			37.983279 °	37.983279 °
				-121.090843 °	-121.090843 °
DWR ID	DWR_NA0017_16_s _ 2015_169				
Action/Comments					
Inspector Comments: 8/20/2014: No significant change observed. 9/12/2013: Site has been surveyed and the erosion has worsened since last year. 08/22/2012: Discontinuous scarp or pocket erosions occurred along a long stretch of the river, with an erosion height greater than 25 ft. at certain points. There is no levee structure on site. The levee crest width and levee height were not measured or estimated in the field. [2014 Site ID:NA0017U16RM16.27]

Downstream view of the site from the right river bank.

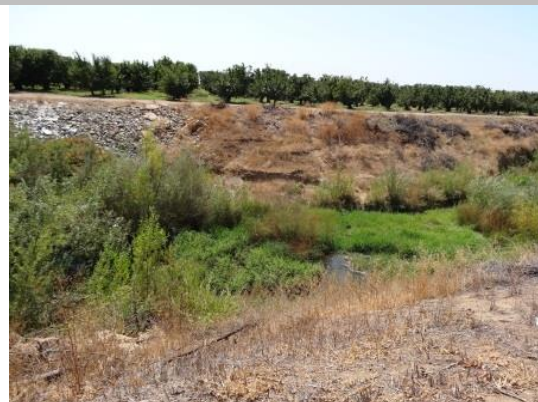
Photo 1 of 1 : SP_2015_NA0017_160_168_20150313_00102.jpg

LM Start	7.30	Rating **	U	Issue No.	168
LM End	7.30	Issue Type +	Ma	Location *	WS
Category	Supplemental			GPS Latitude/Longitude	
				Start	End
Item	DWR Erosion Survey			37.978194 °	37.978194 °
				-121.101696 °	-121.101696 °
DWR ID	DWR_NA0017_16_s_2015_168				
Action/Comments					
Inspector Comments: 8/20/2014: No significant change observed. Note the site ID changed from NA0017U16RM10.82 to NA0017U16RM15.57 to reflect the correct river mile. 09/12/2013: The site is located at immediately downstream of a levee segment protected by broken concrete. There is no levee structure on site. The levee crest width and levee height were not measured or estimated in the field. [2014 Site ID:NA0017U16RM15.57]

View of the site from the right river bank.

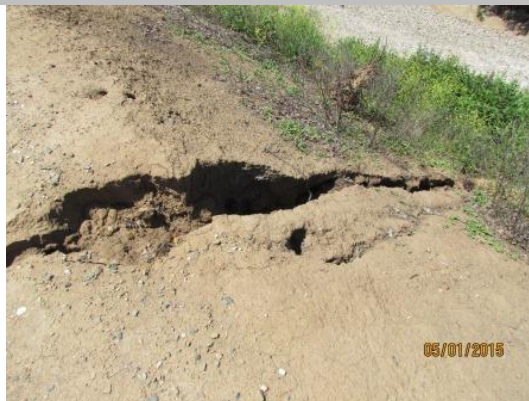
Photo 1 of 1 : SP_2015_NA0017_160_246_20150506_00166.jpg

LM Start	7.39	Rating **	M	Issue No.	246
LM End	7.39	Issue Type +	Ma	Location *	WS
Category	Earthen Levee			GPS Latitude/Longitude	
				Start	End
Item	Erosion / Bank Caving			37.977610 °	37.977610 °
				-121.103159 °	-121.103159 °
DWR ID	DWR_NA0017_16_s_2015_246				
Action/Comments					
Note and monitor erosion site.

Erosion was found on the waterside shoulder of the levee looking downstream.

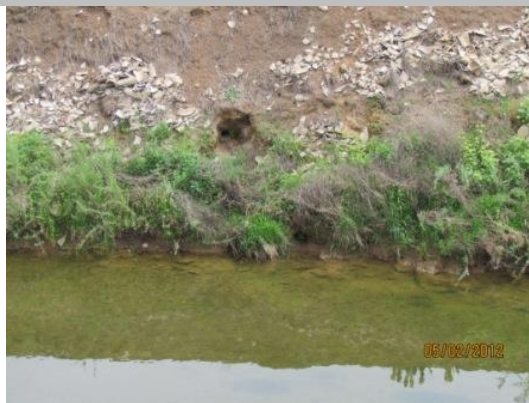
Photo 1 of 1 : SP_2015_NA0017_160_218_20150313_00138.jpg

LM Start	7.57	Rating **	U	Issue No.	218	
LM End	7.57	Issue Type +	Ma	Location *	WS	
Category	Earthen Levee			GPS Latitude/Longitude		
				Start		End
Item	Animal Control				o	o
					o	o
DWR ID	DWR_NA0017_16_s_2012_218					
Action/Comments						
No rodents visible, but rodent burrows visible; need to backfill and compact or grout burrows.

A possible beaver den was found on waterside slope of the levee. The picture was taken from the opposite bank of the levee.

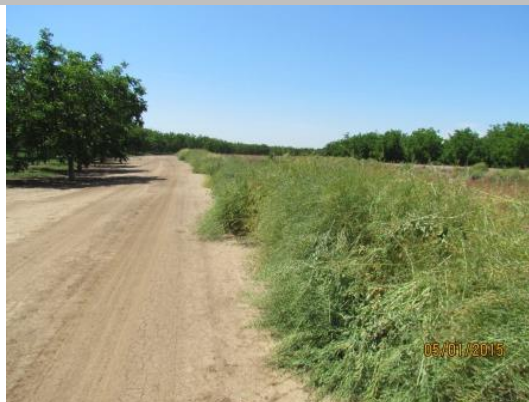
Photo 1 of 1 : SP_2015_NA0017_160_247_20150506_00168.jpg

LM Start	8.21	Rating **	M	Issue No.	247
LM End	12.62	Issue Type +	Ma	Location *	WS
Category	Earthen Levee			GPS Latitude/Longitude	
				Start	End
Item	Vegetation			37.970031 °	37.960214 °
				-121.114035 °	-121.190996 °
DWR ID	DWR_NA0017_16_s_2015_247				
Action/Comments					
Control annual grass and weeds on the levee slopes and easements.

View of vegetation along waterside looking downstream.

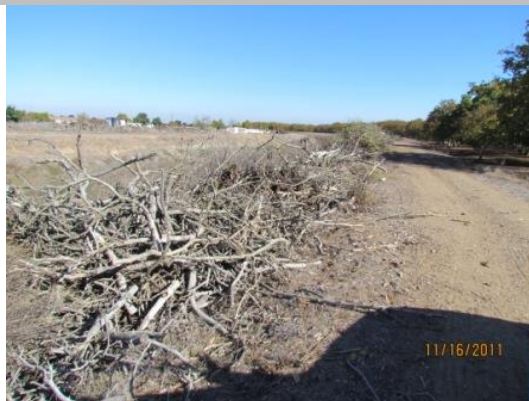
Photo 1 of 1 : SP_2015_NA0017_160_79_20150313_00044.jpg

LM Start	8.29	Rating **	M	Issue No.	79
LM End	8.41	Issue Type +	Ma	Location *	WS
Category	Earthen Levee			GPS Latitude/Longitude	
				Start	End
Item	Encroachments			37.969472 °	37.969114 °
				-121.115350 °	-121.117417 °
DWR ID	DWR_NA0017_16_s_2012_79				
Action/Comments					
Prunings

Prunings were found on the waterside of the levee looking upstream.

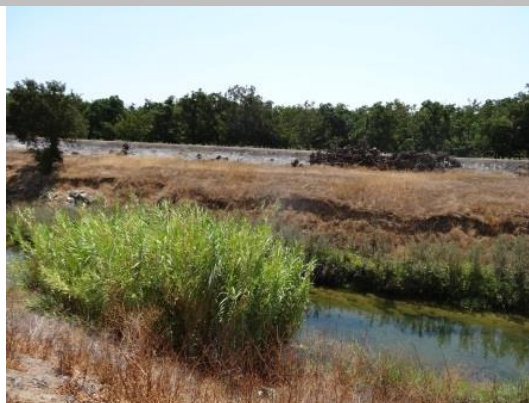
Photo 1 of 1 : SP_2015_NA0017_160_166_20150313_00100.jpg

LM Start	8.36	Rating **	M	Issue No.	166
LM End	8.36	Issue Type +	Ma	Location *	WS
Category	Supplemental			GPS Latitude/Longitude	
				Start	End
Item	DWR Erosion Survey			37.969213 °	37.969213 °
				-121.116574 °	-121.116574 °
DWR ID	DWR_NA0017_16_s_2015_166				
Action/Comments					
Inspector Comments: 8/20/2014: No significant change observed. 9/12/2013: No significant change observed. 08/22/2012: The erosion occurred on a berm of approximately 25 ft. wide. Site is covered with dense vegetation. There is no levee structure on site. The levee crest width and levee height were not measured or estimated in the field. [2014 Site ID:NA0017U16RM14.48]

View of the site from the right river bank.

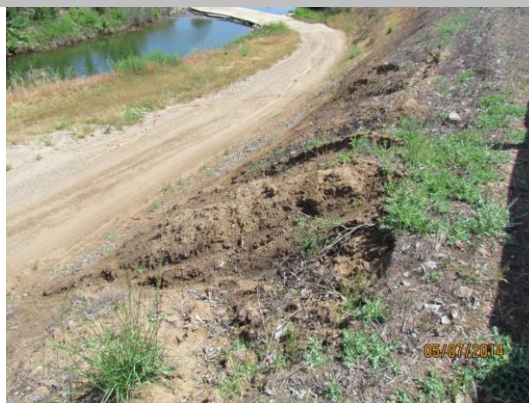
Photo 1 of 2 : SP_2015_NA0017_160_128_20150313_00072.jpg

LM Start	8.60	Rating **	M	Issue No.	128
LM End	8.60	Issue Type +	Ma	Location *	WS
Category	Earthen Levee			GPS Latitude/Longitude	
				Start	End
Item	Slope Stability			37.968157 °	37.968157 °
				-121.120620 °	-121.120620 °
DWR ID	DWR_NA0017_16_s_2013_128				
Action/Comments					
Repair slope instability.

Updated picture of the slope instability on the waterside of the levee looking upstream during spring 2014 inspection.

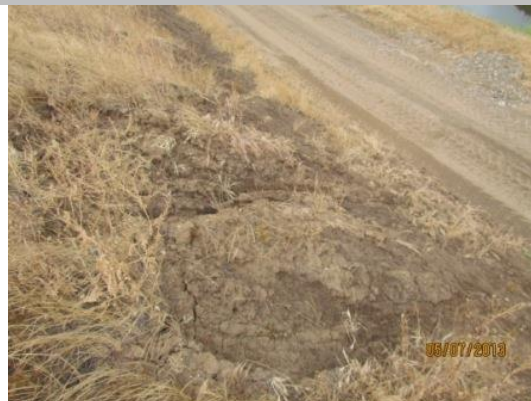
Photo 2 of 2 : SP_2015_NA0017_160_128_20150313_00073.jpg

LM Start	8.60	Rating **	M	Issue No.	128 (cont)	
LM End	8.60	Issue Type +	Ma	Location *	WS	
Category	Earthen Levee			GPS Latitude/Longitude		
				Start		End
Item	Slope Stability			37.968157 °		37.968157 °
				-121.120620 °		-121.120620 °
DWR ID	DWR_NA0017_16_s_2013_128					
Action/Comments						
Repair slope instability.

Slope instability was found on the waterside slope of the levee looking downstream.

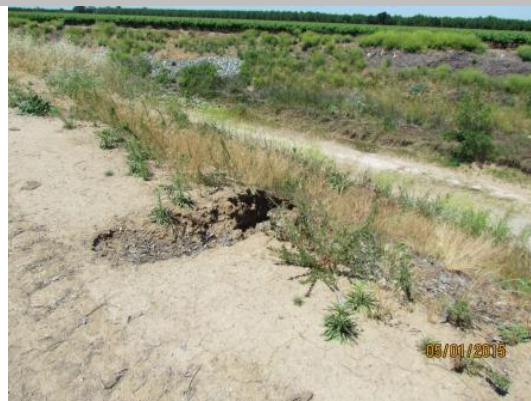
Photo 1 of 1 : SP_2015_NA0017_160_248_20150506_00167.jpg

LM Start	8.68	Rating **	M	Issue No.	248
LM End	8.68	Issue Type +	Ma	Location *	WS
Category	Earthen Levee			GPS Latitude/Longitude	
				Start	End
Item	Erosion / Bank Caving			37.968169 °	37.968169 °
				-121.122047 °	-121.122047 °
DWR ID	DWR_NA0017_16_s_2015_248				
Action/Comments					
Note and monitor erosion site.					
Inspector Comments: Runoff

Erosion was found on the waterside looking downstream.

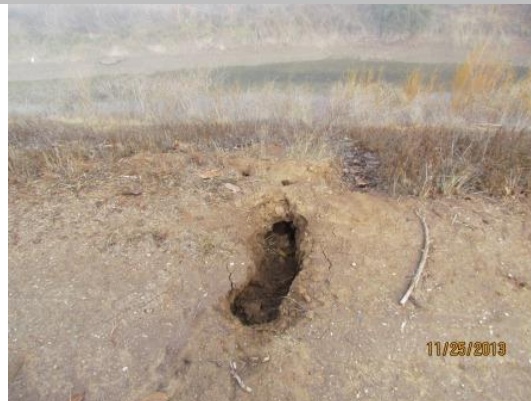
Photo 1 of 1 : SP_2015_NA0017_160_127_20150313_00071.jpg

LM Start	8.68	Rating **	M	Issue No.	127
LM End	8.68	Issue Type +	Ma	Location *	WS
Category	Earthen Levee			GPS Latitude/Longitude	
				Start	End
Item	Animal Control			37.968164 °	37.968164 °
				-121.122184 °	-121.122184 °
DWR ID	DWR_NA0017_16_f_2013_127				
Action/Comments					
No rodents visible, but rodent burrows visible; need to backfill and compact or grout burrows. Inspector Comments: Collapsed animal hole on the waterside shoulder of the levee.

A collapsed animal hole was found on the waterside shoulder of the levee looking upstream.

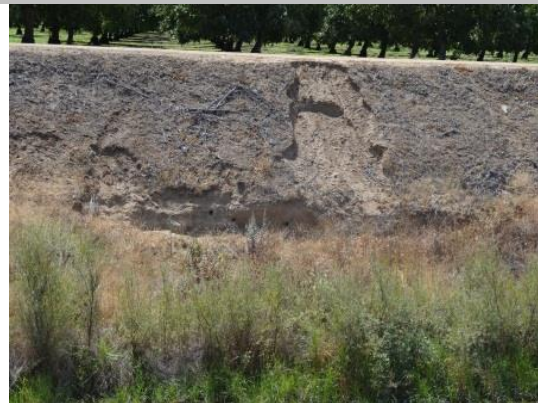
Photo 1 of 1 : SP_2015_NA0017_160_164_20150313_00098.jpg

LM Start	9.02	Rating **	U	Issue No.	164
LM End	9.02	Issue Type +	Ma	Location *	WS
Category	Supplemental			GPS Latitude/Longitude	
				Start	End
Item	DWR Erosion Survey			37.967019 °	37.967019 °
				-121.127581 °	-121.127581 °
DWR ID	DWR_NA0017_16_s_2015_164				
Action/Comments					
Inspector Comments: 8/20/2014: No significant change observed. 9/12/2013: The erosion might have been caused by river flow combined with runoff. Dense vegetation is presents at the site. There is no levee structure on site. The levee crest width and levee height were not measured or estimated in the field. [2014 Site ID:NA0017U16RM13.85]

View of the site from the right river bank.

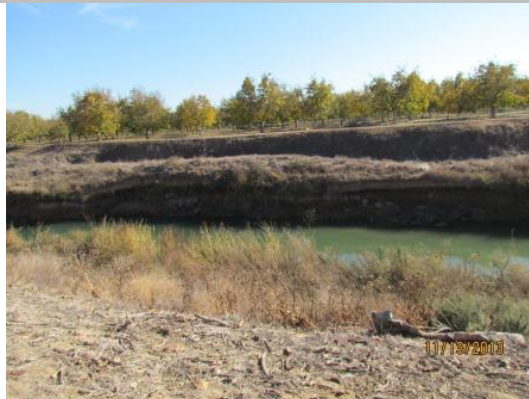
Photo 1 of 1 : SP_2015_NA0017_160_28_20150313_00012.jpg

LM Start	9.48	Rating **	M	Issue No.	28
LM End	9.48	Issue Type +	Ma	Location *	WS
Category	Earthen Levee			GPS Latitude/Longitude	
				Start	End
Item	Erosion / Bank Caving			37.966239 °	37.966239 °
				-121.136172 °	-121.136172 °
DWR ID	DWR_NA0017_16_f_2013_28				
Action/Comments					
Schedule repair of erosion site prior to the next inspection.					
Inspector Comments: Erosion was found on the waterside toe of the levee.

View of the erosion on the waterside toe of the levee looking from the opposite side of the levee.

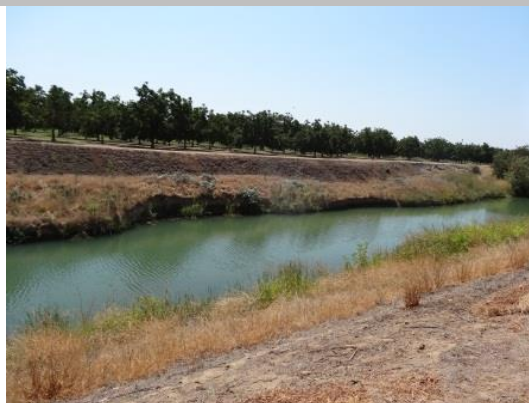
Photo 1 of 1 : SP_2015_NA0017_160_157_20150313_00092.jpg

LM Start	9.58	Rating **	M	Issue No.	157
LM End	9.60	Issue Type +	Ma	Location *	WS
Category	Supplemental			GPS Latitude/Longitude	
				Start	End
Item	DWR Erosion Survey			37.967190 °	37.967190 °
				-121.133080 °	-121.133080 °
DWR ID	DWR_NA0017_16_s_2015_157				
Action/Comments					
Inspector Comments: 8/20/2014: No significant change observed. 9/12/2013: No significant change observed. 08/22/2012: The erosion is on berm. The berm width is estimated. There is no levee structure on site. The levee crest width and levee height were not measured or estimated in the field. [2014 Site ID:NA0017U16RM13.53]

Upstream view of the erosion.

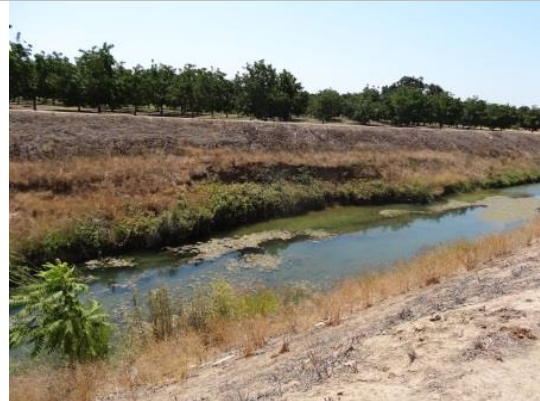
Photo 1 of 1 : SP_2015_NA0017_160_41_20150313_00015.jpg

LM Start	9.87	Rating **	M	Issue No.	41
LM End	9.87	Issue Type +	Ma	Location *	WS
Category	Supplemental			GPS Latitude/Longitude	
				Start	End
Item	DWR Erosion Survey			37.964735 °	37.964735 °
				-121.142503 °	-121.142503 °
DWR ID	DWR_NA0017_16_s_2015_41				
Action/Comments					
Inspector Comments: 8/20/2014: No significant change observed. 9/12/2013: No significant change observed. 08/22/2012: Dense vegetation on site. There is no levee structure on site. The levee crest width and levee height were not measured or estimated in the field. [2014 Site ID:NA0017U16RM12.95]

Downstream view of the site from the right river bank.

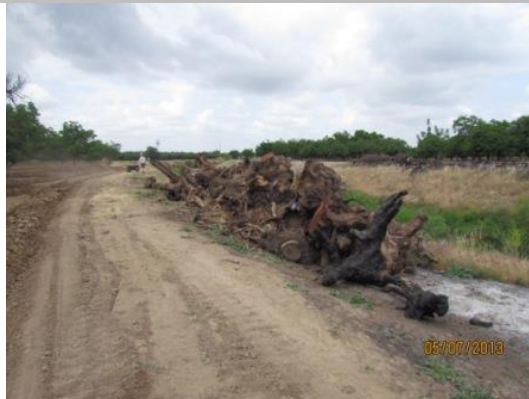
Photo 1 of 2 : SP_2015_NA0017_160_90_20150313_00049.jpg

LM Start	10.75	Rating **	M	Issue No.	90
LM End	10.75	Issue Type +	Ma	Location *	WS
Category	Earthen Levee			GPS Latitude/Longitude	
				Start	End
Item	Encroachments			37.962472 °	37.962472 °
				-121.158112 °	-121.158112 °
DWR ID	DWR_NA0017_16_s _ 2012_90				
Action/Comments					
Prunings

Prunings were found on the waterside shoulder of the levee looking downstream.

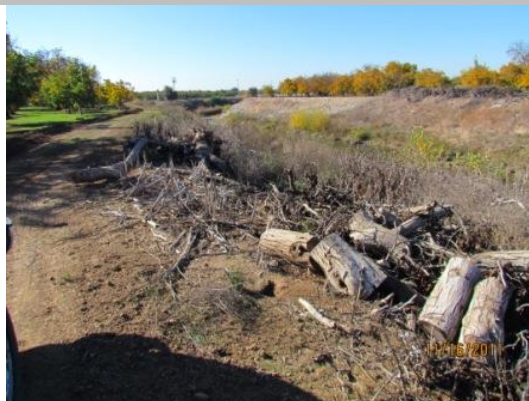
Photo 2 of 2 : SP_2015_NA0017_160_90_20150313_00050.jpg

Prunings were found on the waterside of the levee looking downstream.

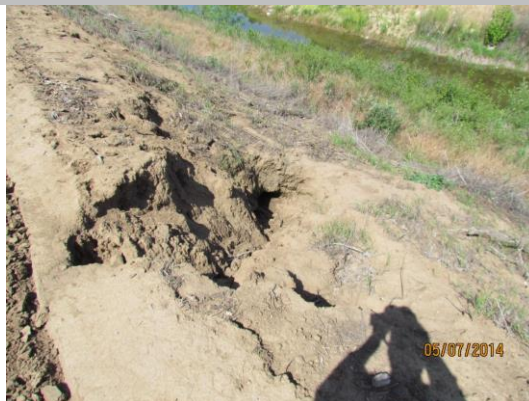
Photo 1 of 2 : SP_2015_NA0017_160_139_20150313_00081.jpg

Updated picture of the erosion on the waterside shoulder of the levee looking downstream.

LM Start	10.79	Rating **	M	Issue No.	139
LM End	10.79	Issue Type +	Ma	Location *	WS
Category	Earthen Levee			GPS Latitude/Longitude	
				Start	End
Item	Erosion / Bank Caving			37.962182 °	37.962182 °
				-121.158684 °	-121.158684 °
DWR ID	DWR_NA0017_16_s _ 2013_139				
Action/Comments					
Schedule repair of erosion site prior to the next inspection.

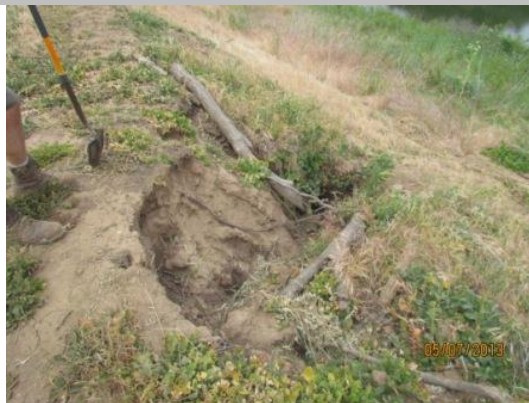
Photo 2 of 2 : SP_2015_NA0017_160_139_20150313_00082.jpg

Erosion was found on the waterside of the levee looking downstream.

LM Start	10.79	Rating **	M	Issue No.	139 (cont)
LM End	10.79	Issue Type +	Ma	Location *	WS
Category	Earthen Levee			GPS Latitude/Longitude	
				Start	End
Item	Erosion / Bank Caving			37.962182 °	37.962182 °
				-121.158684 °	-121.158684 °
DWR ID	DWR_NA0017_16_s_2013_139				
Action/Comments					
Schedule repair of erosion site prior to the next inspection.

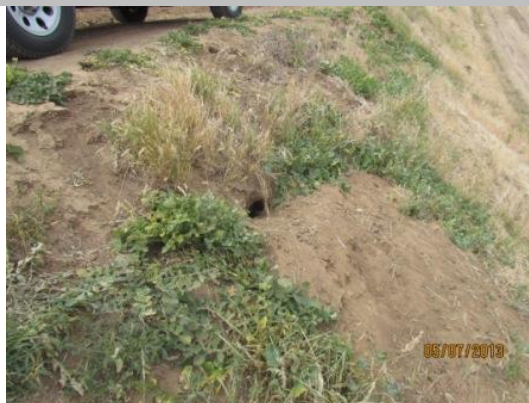
Photo 1 of 1 : SP_2015_NA0017_160_140_20150313_00083.jpg

An animal hole was found on the waterside slope of the levee looking downstream.

LM Start	10.84	Rating **	M	Issue No.	140
LM End	10.84	Issue Type +	Ma	Location *	WS
Category	Earthen Levee			GPS Latitude/Longitude	
				Start	End
Item	Animal Control			37.961681 °	37.961681 °
				-121.159346 °	-121.159346 °
DWR ID	DWR_NA0017_16_s_2013_140				
Action/Comments					
No rodents visible, but rodent burrows visible; need to backfill and compact or grout burrows.

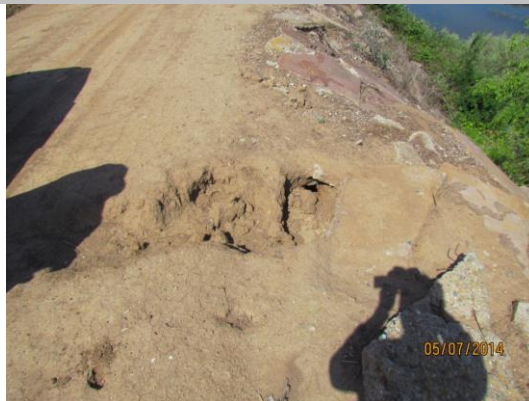
Photo 1 of 1 : SP_2015_NA0017_160_108_20150313_00056.jpg

Rodent holes were found on the waterside shoulder of the levee looking downstream.

LM Start	10.89	Rating **	M	Issue No.	108
LM End	10.89	Issue Type +	Ma	Location *	WS
Category	Earthen Levee			GPS Latitude/Longitude	
				Start	End
Item	Animal Control			37.961494 °	37.961494 °
				-121.160196 °	-121.160196 °
DWR ID	DWR_NA0017_16_s_2014_108				
Action/Comments					
No rodents visible, but rodent burrows visible; need to backfill and compact or grout burrows.

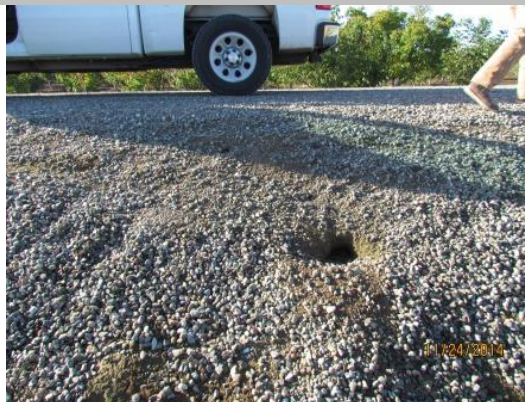
Photo 1 of 1 : SP_2015_NA0017_160_261_20150313_00151.jpg

An animal hole was found on the waterside shoulder of the levee looking downstream.

LM Start	12.94	Rating **	M	Issue No.	261
LM End	12.94	Issue Type +	Ma	Location *	WS
Category	Earthen Levee			GPS Latitude/Longitude	
				Start	End
Item	Animal Control			37.960292 °	37.960292 °
				-121.196308 °	-121.196308 °
DWR ID	DWR_NA0017_16_f_2014_261				
Action/Comments					
No rodents visible, but rodent burrows visible; need to backfill and compact or grout burrows.

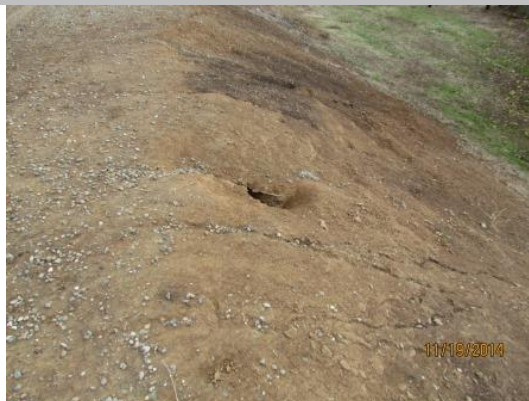
Photo 1 of 1 : SP_2015_NA0017_160_260_20150313_00150.jpg

Rodent holes were found on the landside slope of the levee looking upstream.

LM Start	14.48	Rating **	M	Issue No.	260
LM End	14.48	Issue Type +	Ma	Location *	LS
Category	Earthen Levee			GPS Latitude/Longitude	
				Start	End
Item	Animal Control			37.968800 °	37.968800 °
				-121.220755 °	-121.220755 °
DWR ID	DWR_NA0017_16_f_2014_260				
Action/Comments					
No rodents visible, but rodent burrows visible; need to backfill and compact or grout burrows.

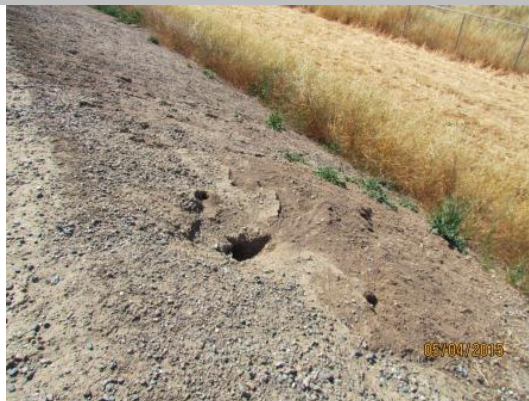
Photo 1 of 1 : SP_2015_NA0017_160_273_20150506_00169.jpg

Rodent holes were found on the landside of the levee looking upstream.

LM Start	14.61	Rating **	M	Issue No.	273
LM End	14.61	Issue Type +	Ma	Location *	LS
Category	Earthen Levee			GPS Latitude/Longitude	
				Start	End
Item	Animal Control			37.969913 °	37.969913 °
				-121.222870 °	-121.222870 °
DWR ID	DWR_NA0017_16_s_2015_273				
Action/Comments					
No rodents visible, but rodent burrows visible; need to backfill and compact or grout burrows.

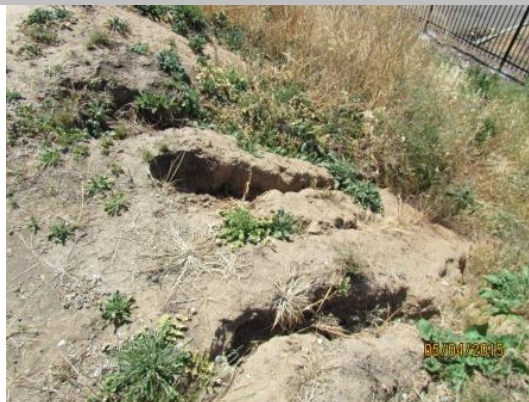
Photo 1 of 2 : SP_2015_NA0017_160_150_20150506_00170.jpg

Updated picture of the erosion on the landside shoulder of the levee looking upstream during spring 2015 inspection.

LM Start	16.43	Rating **	M	Issue No.	150
LM End	16.43	Issue Type +	Ma	Location *	LS
Category	Earthen Levee			GPS Latitude/Longitude	
				Start	End
Item	Erosion / Bank Caving			37.982318 °	37.982318 °
				-121.252095 °	-121.252095 °
DWR ID	DWR_NA0017_16_s_2013_150				
Action/Comments					
Schedule repair of erosion site prior to the next inspection.					
Inspector Comments: Runoff
